Image of oil filter adapter from Y Block engine being reformed so it will seal tighter against the gasket

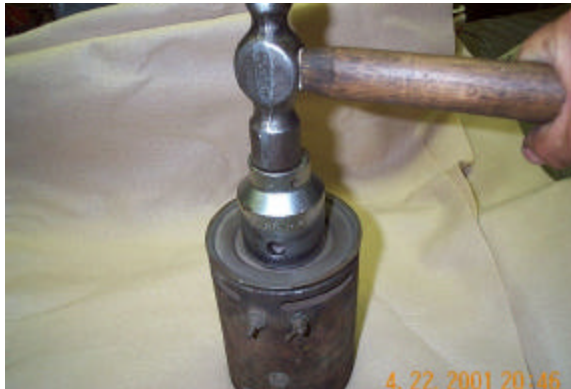
When placed on a flat surface the center hole should be up about 1/16" from surface so that when it is secured in place much force will be exerted upon the gasket

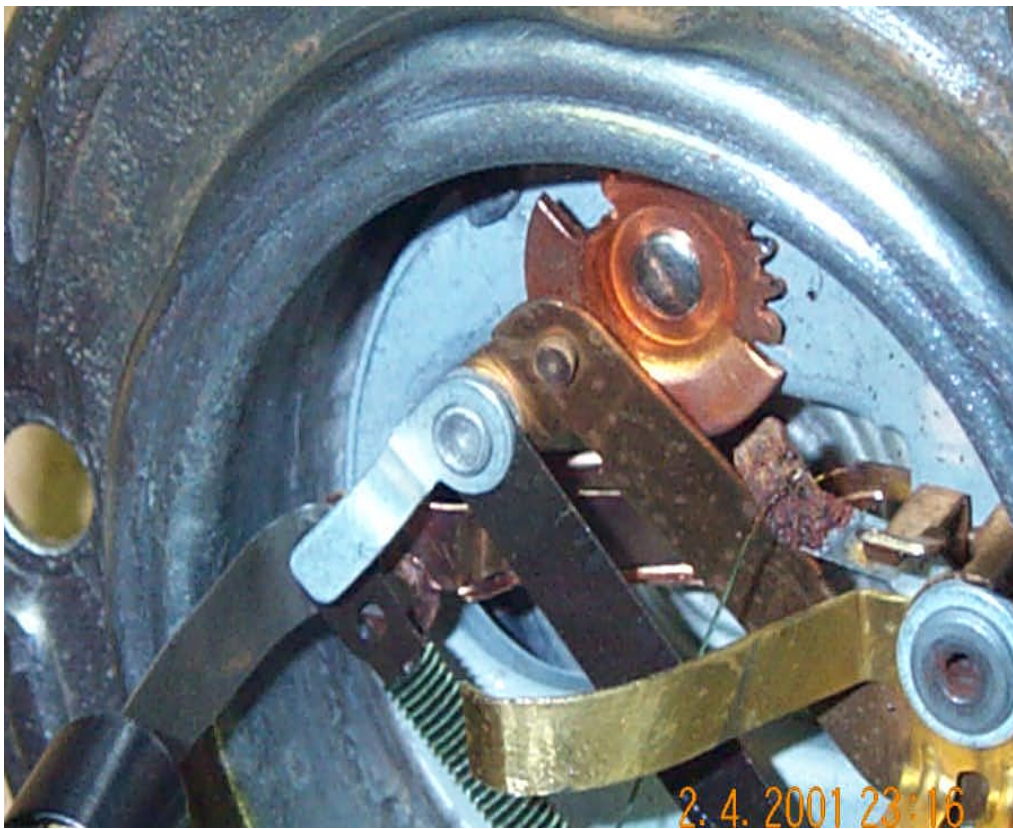
Image of a 6V or 12V fuel sender from a 55 or 56 T Bird. Note the burnishing tool in position for burnishing contacts. Oxidized contacts are most often all that is wrong with these sending units.
